TEST REPORT

CLIENT: Applied Innovative Technologies
PO Box 754
Fort Lupton, CO 80621
Attn.: Steve Vettori

MATERIALS: Thirteen new Nightstar flashlights were delivered by the client and marked with numbers "1" through "13" by Hauser. All the flashlights were clear. Flashlights 1-12 were identical. Flashlight #13 was identified as an "improved version" and had a foam insert inside the unit as a sound damper, an improved seal around the lens, and an additional flat area on the side of the handle with the marking "Nature and technology can coexist."

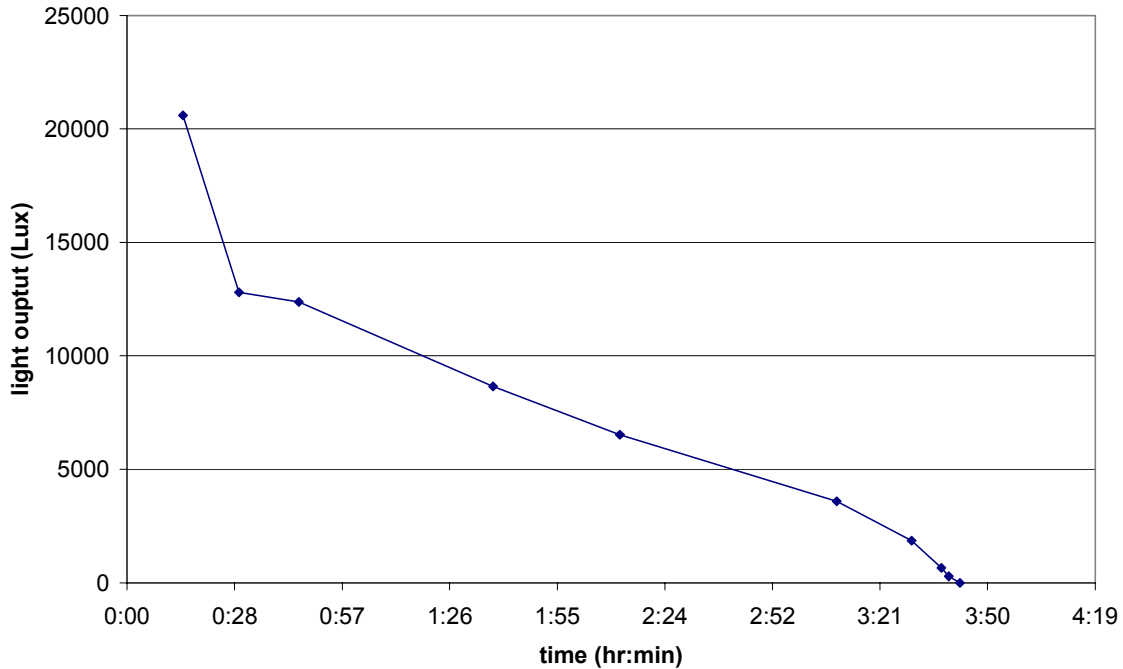
Graph 3. Total light output of Maglite over time

Graph 3 above shows the total light output from the Maglite over time, as the batteries wear out. The light had been used for a time estimated to be about 15 minutes in previous testing before this data was taken. The total light output was measured with the lens placed directly against the meter. The total light output with a different, new set of batteries was measured at 29,500 Lux after 30 seconds of total use. The light output dropped to 20,300 Lux after 14 minutes of continuous use.

Graphs 1 and 2 show the mapping of the light pattern from each type of light. Graph 3 shows the total light output of the Maglite over time (as the batteries wear out), measured with the meter against the lens of the flashlight.

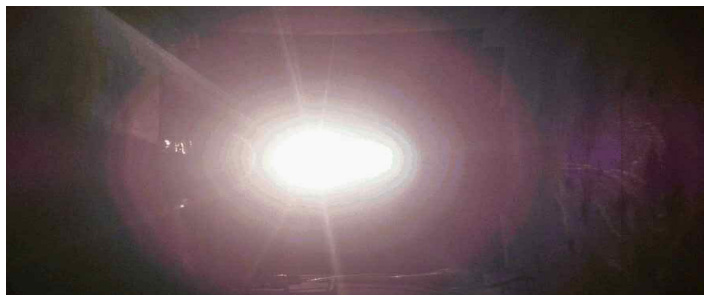
Image 1. Light from both flashlights with no smoke in the box. The light output at 8 feet was measured at 172 Lux for the Maglite and 1.92 Lux for the Nightstar.

Images 1 - 3 were taken with a digital camera in place of the light meter in the smoke box at a distance of 8 feet from the flashlights. These images were taken to give a visual indication of the appearance of the lights through smoke. In each image, both lights were on and had been on for approximately 30 seconds.

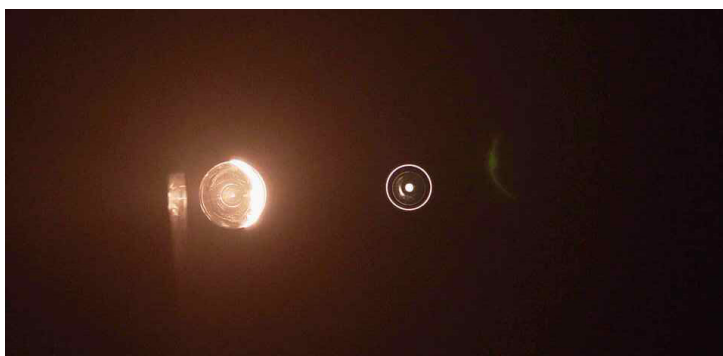
Image 2. Light from both flashlights with the box full of smoke from smoldering paper. The Nightstar is the light on the right. The light output at 8 feet was measured at 1.32 Lux for the Maglite and 0.07 Lux for the Nightstar.

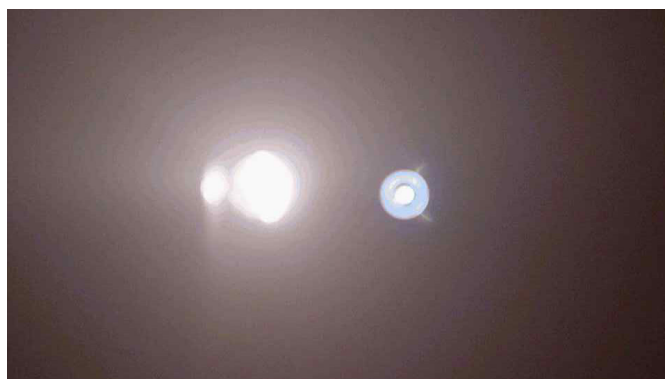
Image 3. Light from both flashlights after some of the smoke was removed from the box. The light output from the Maglite was measured at 3.61 Lux and the output from the Nightstar was 0.16 Lux.
