REPORT OF EXPLOSIVE ATMOSPHERE TEST
 ON
 TWO (2) NIGHTSTAR FLASHLIGHTS
 FOR
 APPLIED INNOVATION TECHNOLOGIES, INC.
 FORT LUPTON, COLORADO

WRITTEN BY	<i>Salim Khabieh</i>	REPORT	3-4493
CHECKED BY	<i>Denese Pootan</i>	AERO NAV S.O.	4493
APPROVED BY	<i>Gyanchand Pooles</i>	CUSTOMER P.O.	399
DATE	June 16, 2003	CONTRACT NO.:	
GOVERNMENT QAR	NO INSPECTION REQUIRED	NONE

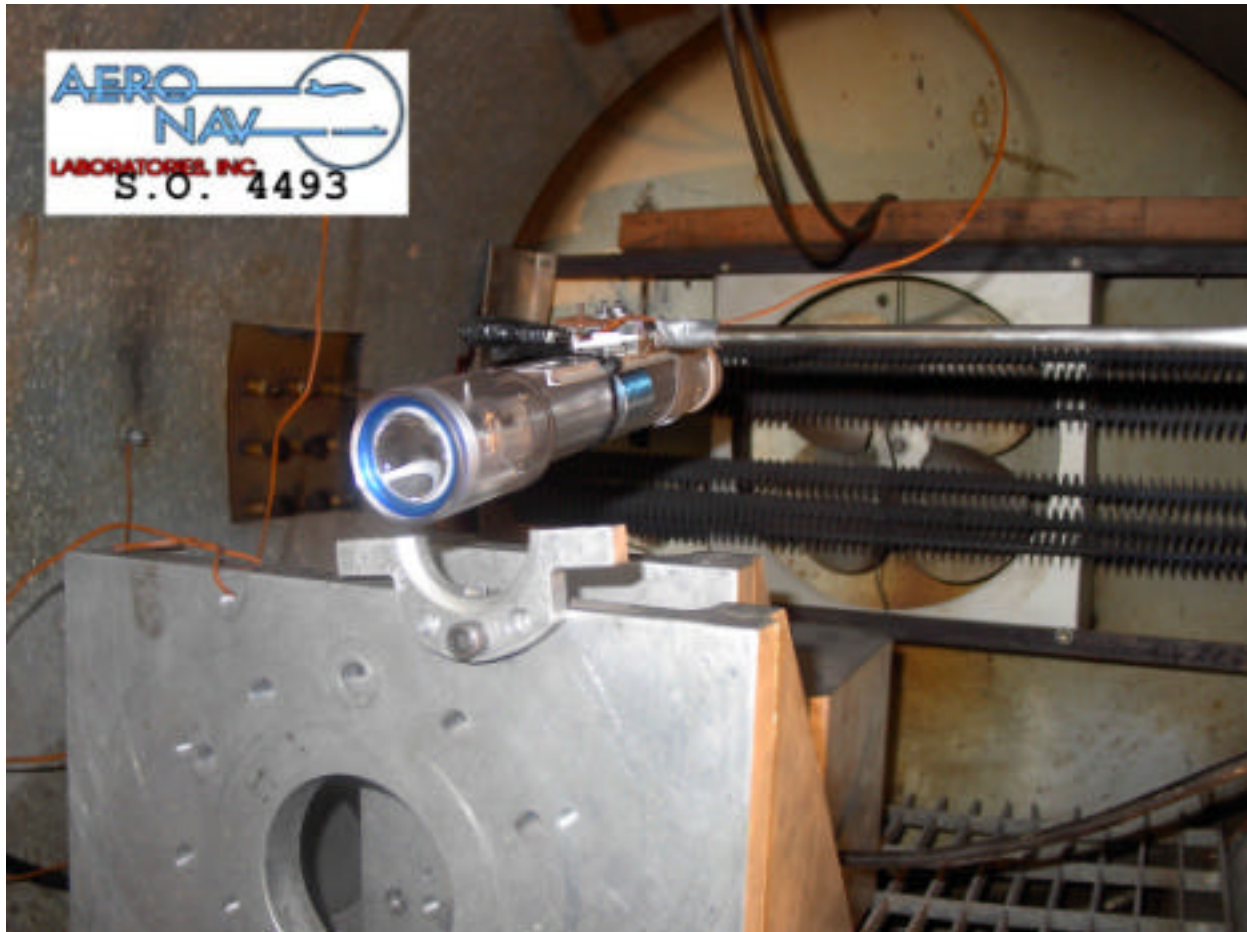
APPLIED INNOVATION TECHNOLOGIES, INC.
FORT LUPTON, COLORADO
The First NightStar Flashlight
Explosive Atmosphere Test Setup (Photograph #1)

4.1.1 Explosive Atmosphere Test (The First NightStar Flashlight):

The NightStar Flashlight was charged for a total period of three (3) minutes and subjected to the Explosive Atmosphere Test as follows:

The NightStar Flashlight was placed in the test chamber in such a manner that it can be shaken and operated from outside of the chamber. The test altitude was at sea level. The highest operating temperature for the NightStar was 55°C.

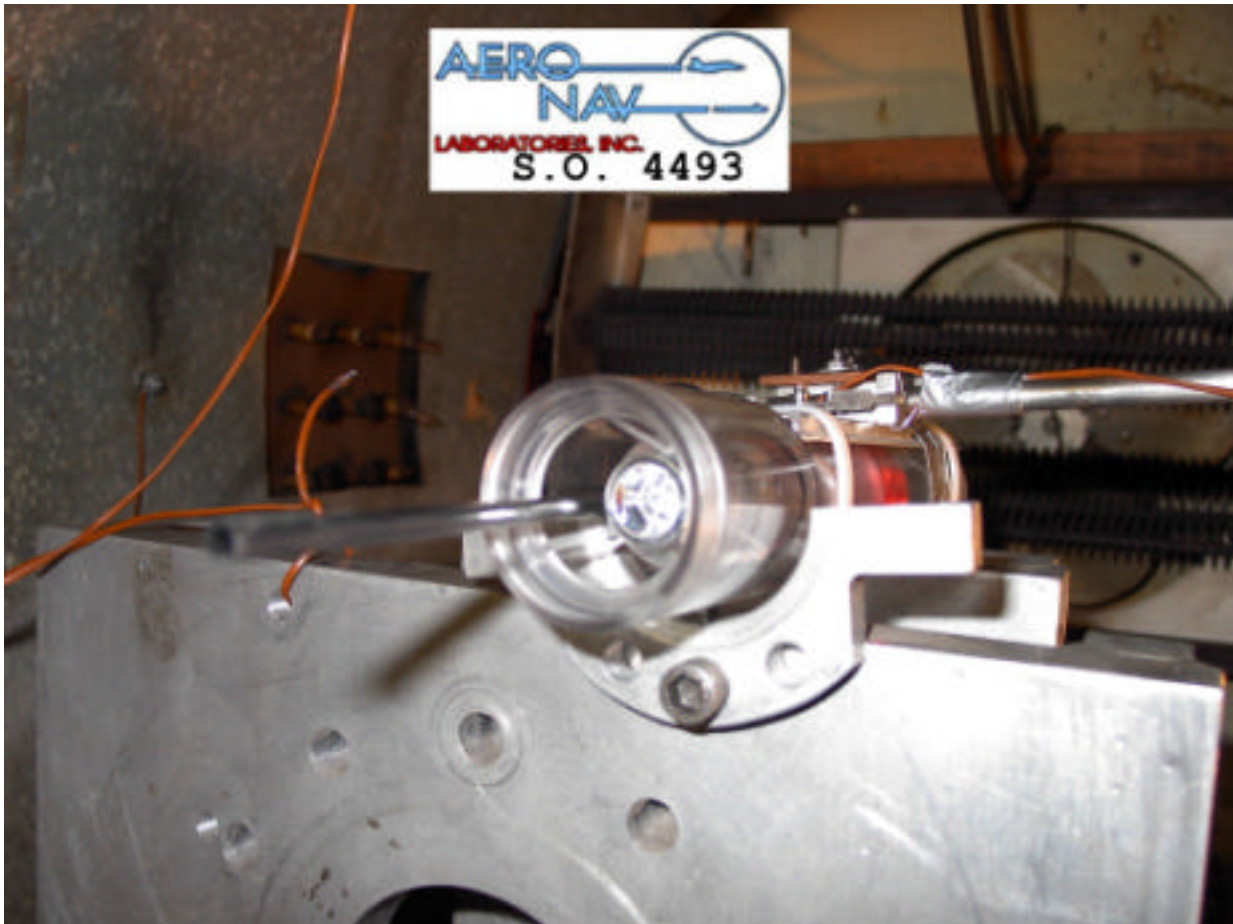
APPLIED INNOVATION TECHNOLOGIES, INC.
FORT LUPTON, COLORADO
The Second NightStar Flashlight
Explosive Atmosphere Test Setup (photograph #2)

4.1.2 Explosive Atmosphere Test, Simulated Housing Seal Rupture (The Second NightStar Flashlight):

The above Explosive Atmosphere Test (paragraph 4.1.1) was repeated using Hydrogen, except the NightStar Flashlight housing seal was ruptured to allow for the explosive mixture penetration.
