# **APPLIED INNOVATIVE TECHNOLOGIES, INC.**

## **NightStar Marine Testing: Tested in compliance to ASTM F1014-02: Test standard for all marine flashlights. Test performed by Aero-Nav Labs**

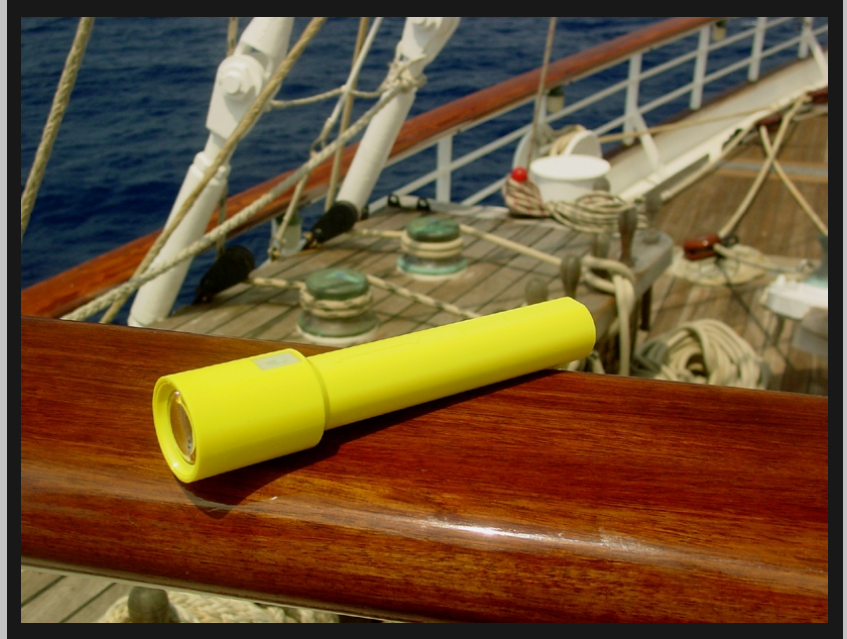
( ) Low Impact: NightStar was placed in a cold chamber at -40 F (-40 C) for 2 hours. Immediately following the "cold soak" NightStar was subjected to a 2-lbf.in (1.4 N.m) impact using a 1-lb (0.4 kg) steel ball dropped from a height of 1-ft. (0.3 m) onto the impact target areas listed above.

( ) High Impact: After the low impact test NightStar was again placed in the cold chamber at -40 F (-40 C) for 2 hours. After the second cold soak, NightStar light was subjected to a 20-lbf.in (2.3 N.m) impact using the 1-lb steel ball dropped from a height of 1.8-ft (0.5 m) onto the impact target areas.
